Maryland Inventory of Historic Properties Number: AL-VI-B-337

Name: MD 36 over Georges Creek (1014)

MARYLAND INVENTORY OF HISTORIC BRIDGES
HISTORIC BRIDGE INVENTORY
MARYLAND STATE HIGHWAY ADMINISTRATION/
MARYLAND HISTORICAL TRUST

SHA Bridge No. 1014 Bridge name MD 36 over Georges Creek

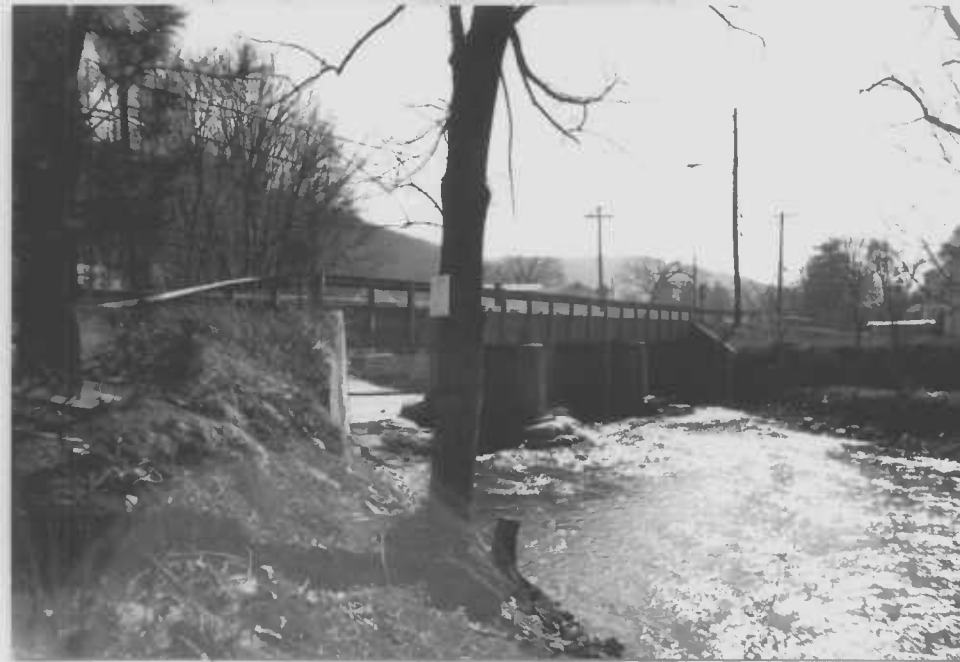
8. 1 of 6

7 Upstream elevation

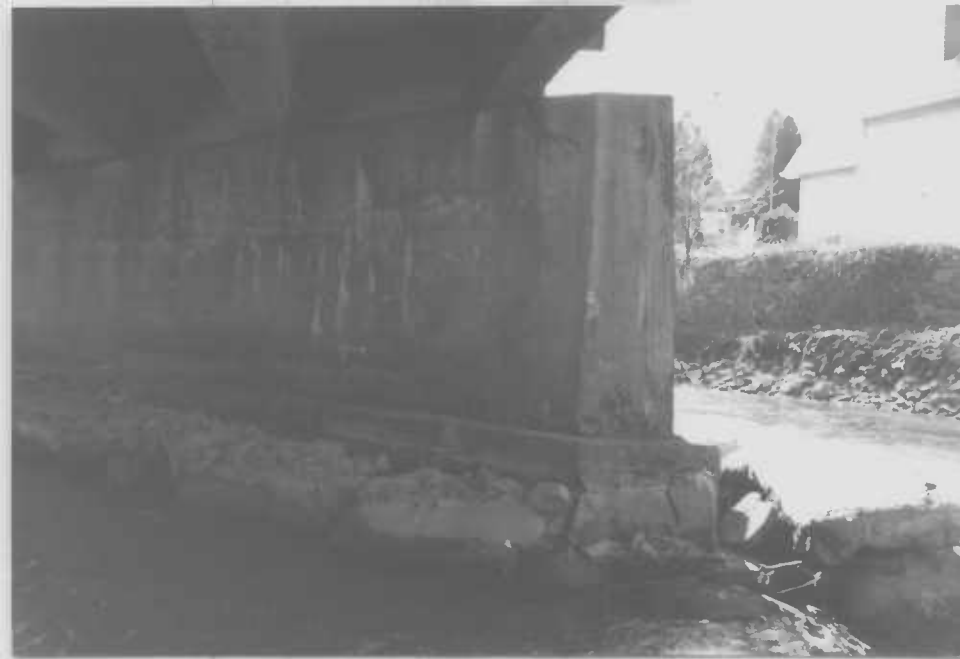
8 2 of 6

7 Detail of pier

According to the 1996 inspection report, this structure was in fair condition with concrete erosion at the piers, debris in the stream channels, and deteriorated concrete. The asphalt wearing surface has depressions in the traffic lanes. The concrete is cracked, scaling, and spalling on the piers, abutments, and deck. The underside of the deck and concrete beams have areas of spalled concrete, rust, exposed reinforcing bars, and efflorescence.

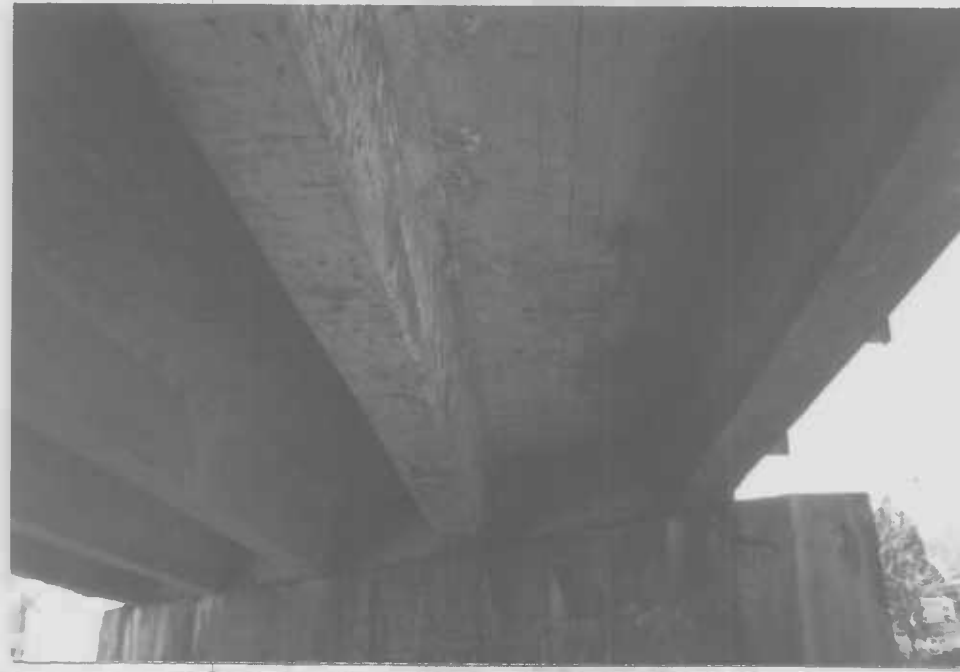
8 3 of 6

7 Detail of beam

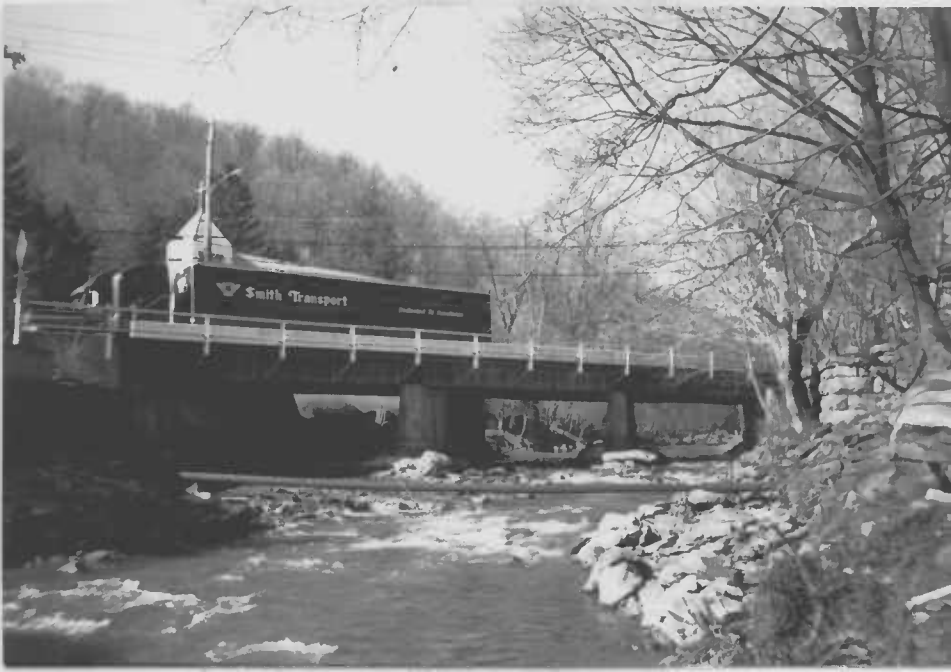
- 1 AL-VI-B-337
- 2 MD 36 over George's Creek
- 3 Allegany Co, MD
- 4 Ryan McIsay
- 5 3/97
- 6 MD SHPO
- 7 Downstream elevation
- 8 4 & 6

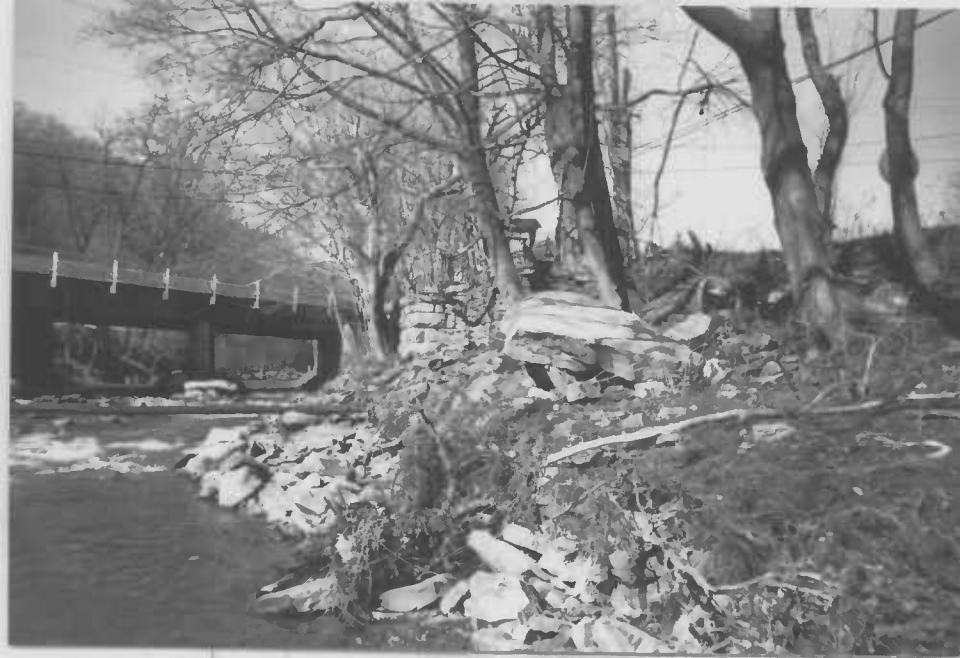
- 1 AL-VI-B-337
- 2 MD 36 over George's Creek
- 3 Allegany Co, MD
- 4 Ryan McKay
- 5 3/97
- 6 MD SHPO
- 7 A butment of original bridge
- 8 5 of 6

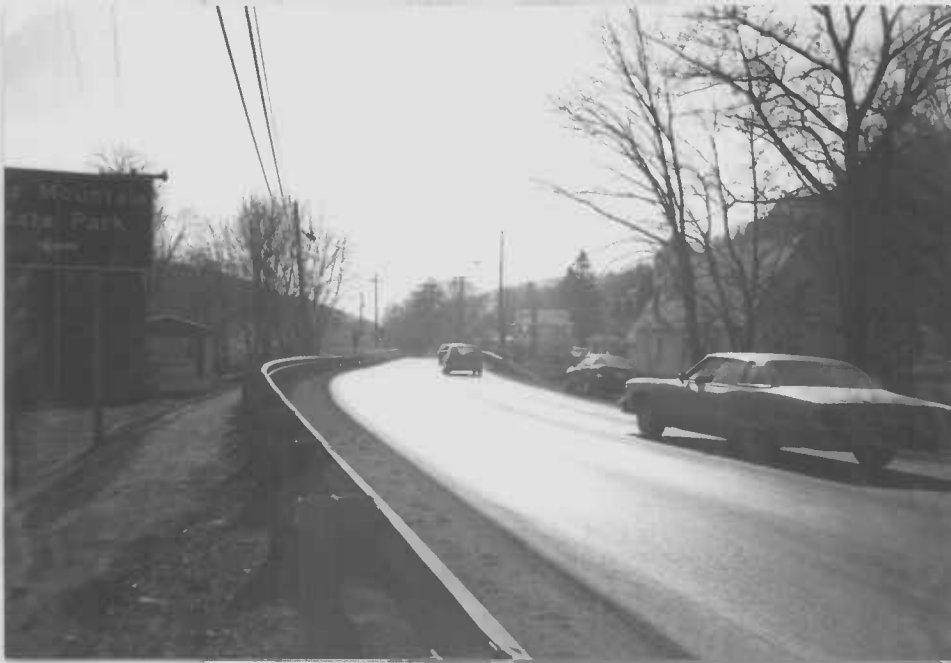
- 1 AL-VI-B-337
- 2 MD 36 over George's Creek
- 3 Allegany Co, MD
- 4 Ryan McKay
- 5 3/97
- 6 MD SHPO
- 7 North approach
- 8 6 of 6
